PASSAIC RIVER BASIN  
DEN BROOK, MORRIS COUNTY  
NEW JERSEY

# OPENAKA LAKE DAM

## NJ 00780

PHASE 1 INSPECTION REPORT  
NATIONAL DAM SAFETY PROGRAM

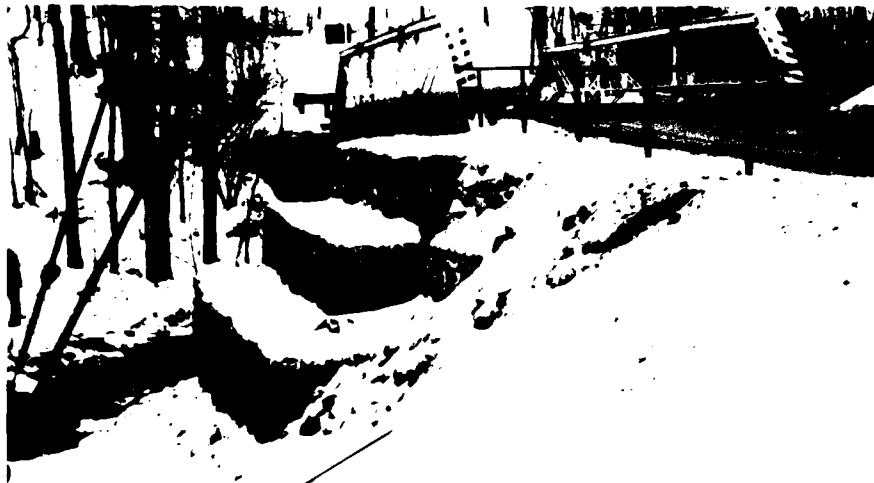
The gabions forming a portion of downstream side of the left embankment appeared to be stable and in good condition. The downstream side adjacent to the gabions for a length of about 10 feet was covered with riprap which appeared to provide adequate slope protection. The remainder of the downstream side consisted of unprotected soil containing no vegetation.

PHOTO 5  
DOWNSTREAM SIDE OF DAM

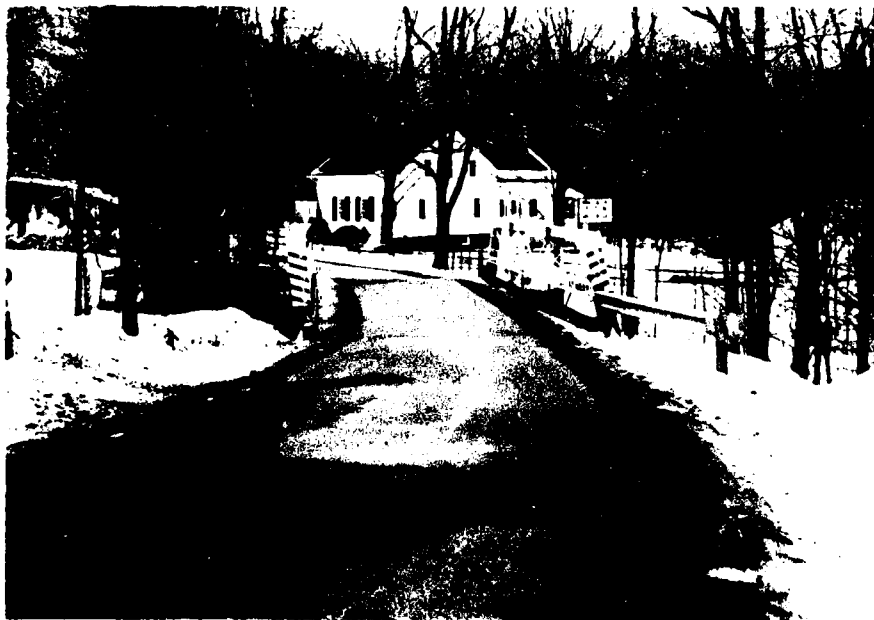
The right and left embankments were overgrown with trees and bushes on their upstream side. The trees ranged in size from 2 inches to 12 inches. The roadway pavement was patched but appeared to be in satisfactory condition. Near the right end of the stone rubble wall on the downstream side right embankment where the wall is about 3 feet high, the wall was bulging out approximately 1 foot due to sloughing of the embankment. The wall however, was not undermined at its base. The remainder of the wall which is composed of grouted stone appeared to be in generally satisfactory condition. An 8-inch deep depression in the soil approximately 4 feet to the right of the spillway

PHOTO 6  
CREST OF DAM

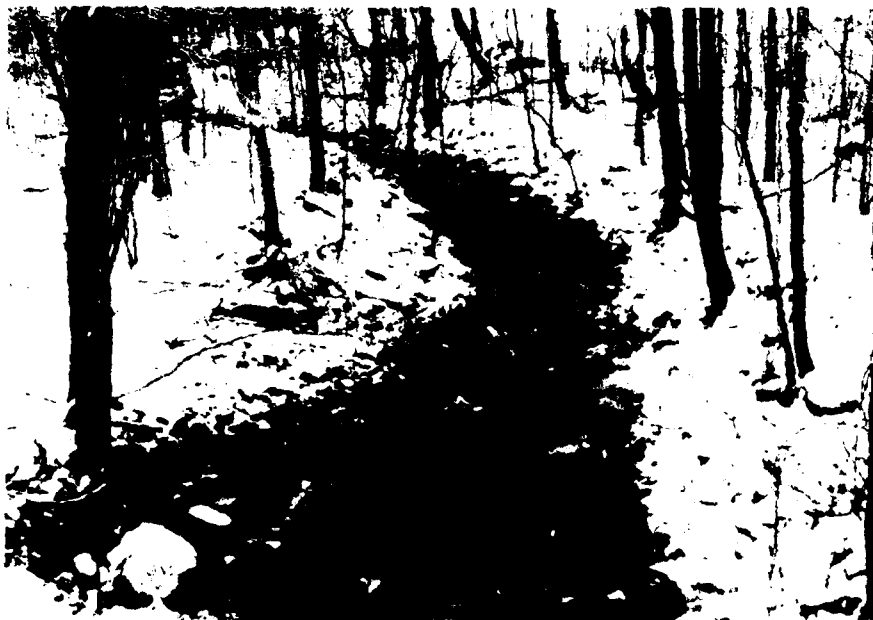
PHOTO 10

Orange stains were noted on several of the rocks in the bed of the downstream channel. These stains could be rust stains from the low level outlet pipe which was severely rusted. Orange stains were also noted on the rocks and in the bed of the downstream channel on its left bank approximately 20 feet downstream from the downstream toe of the dam. These orange deposits did not appear to be rust stains, but could have been related to seepage.

DOWNSTREAM CHANNEL
